SUBJECT: Final Case Closure with Continuing Obligations
Firestone Property, S73W16437 Janesville Rd, Muskego
DNR BRRTS # 03-68-554227 PECFA # 53150-9723-37-A
FID #: 268181540

This site was formerly used as a vehicle repair shop that had soil and groundwater contaminated with petroleum and hydraulic oil compounds. Responses included cleaning and removal of the former tank system and soil excavation. The conditions of closure and continuing obligations required were based on the property being used for commercial purposes.

Cap Maintenance Plan

**Former Firestone Property
S73 W16437 Janesville Road
Muskego, Wisconsin**

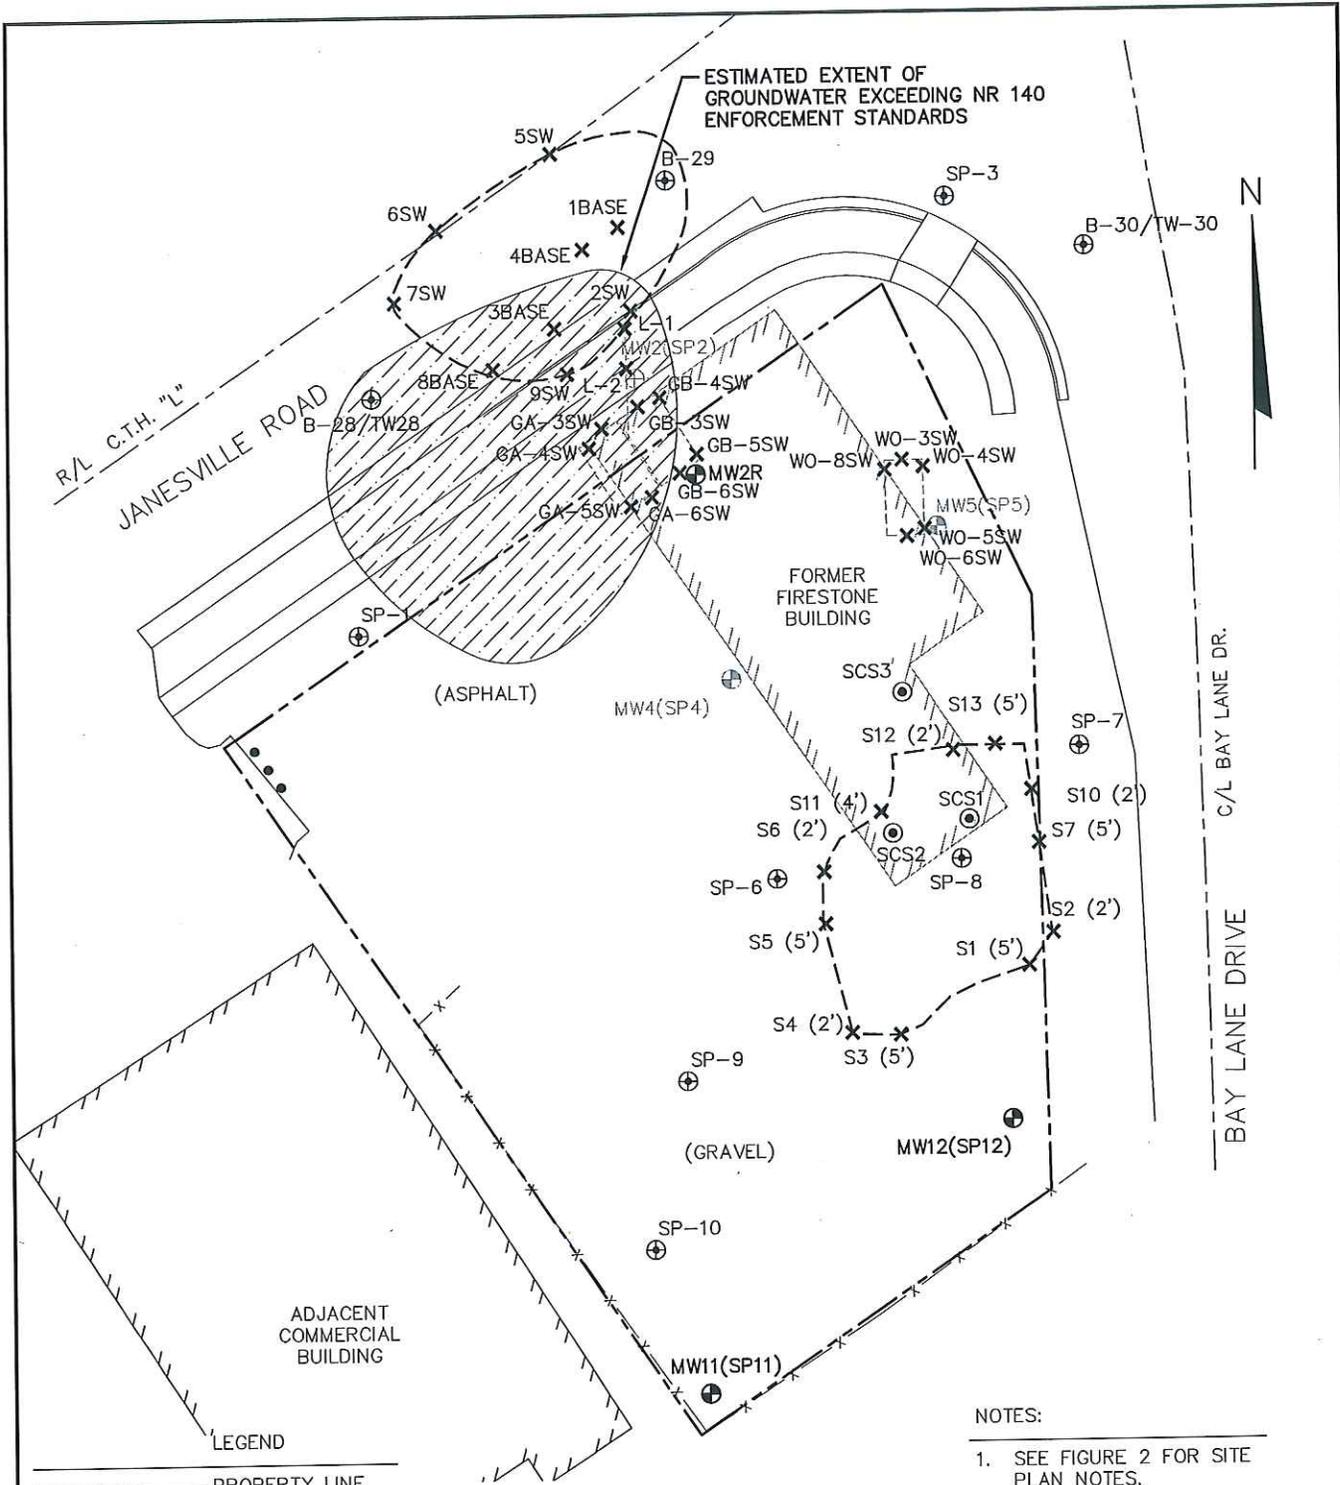
CLIENT	WAUKESHA COUNTY 515 W. MORELAND BLVD. WAUKESHA, WI 53188	SITE	FORMER FIRESTONE PROPERTY S73 W16437 JANESVILLE ROAD MUSKEGO, WISCONSIN	ENGINEER	SCS ENGINEERS 2830 DAIRY DRIVE MADISON, WI 53718-6751 PHONE: (608) 224-2830	GROUNDWATER ANALYTICAL RESULTS	FIGURE 7
	PROJECT NO.		25212113.00				
	DRAWN:	06/19/13	CHECKED BY:	REL			
	REVISED:	06/19/13	APPROVED BY:	REL 11/14/13

Groundwater contamination greater than enforcement standards is present both on this contaminated property and off this contaminated property, as shown on the attached map Groundwater Analytical Results, Figure 7, Revised 06/19/13. If you intend to construct a new well, or reconstruct an existing well, you'll need prior DNR approval. Affected property owners and right-of-way holders were notified of the presence of groundwater contamination.

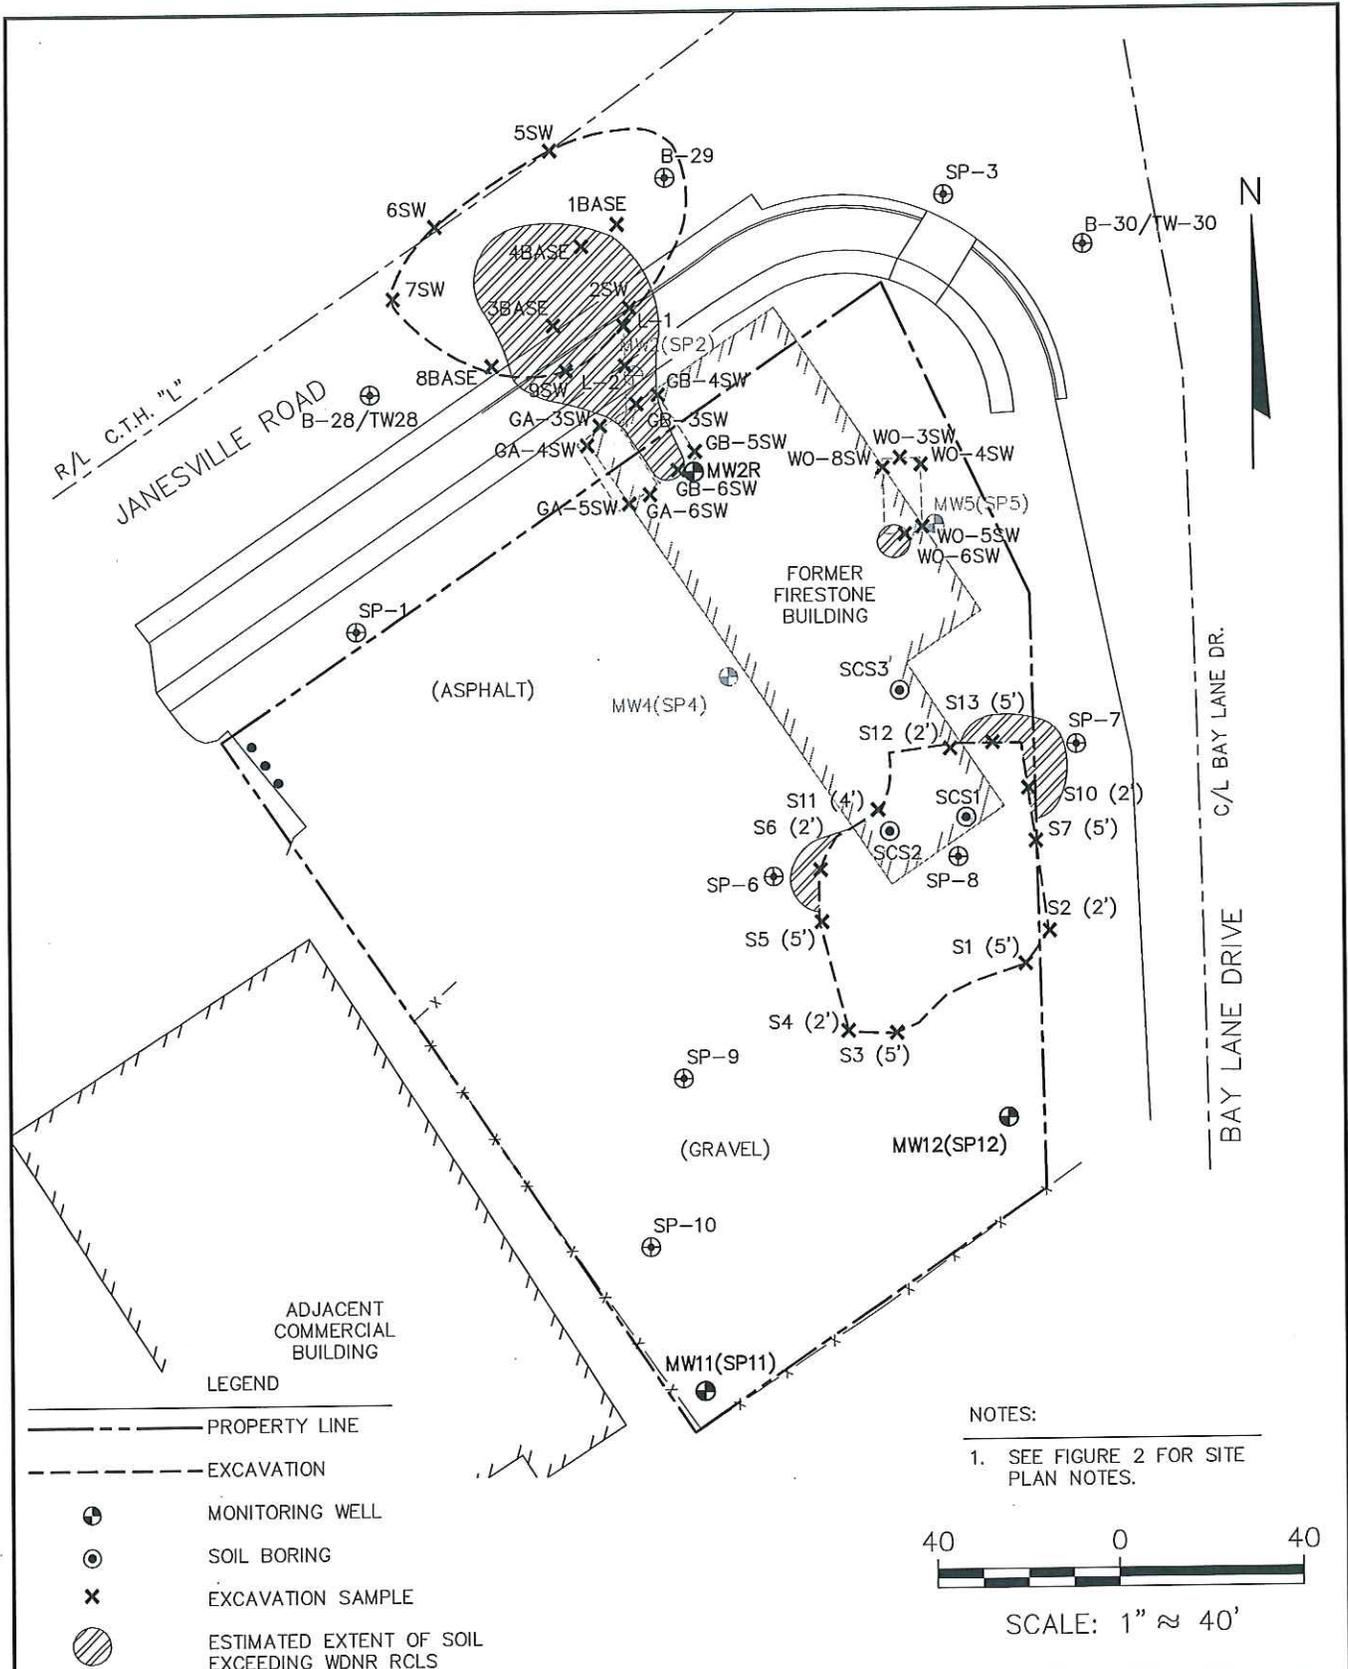
- PROPERTY LINE
- EXCAVATION
- MONITORING WELL
- SOIL BORING
- EXCAVATION SAMPLE
- ESTIMATED EXTENT OF SOIL EXCEEDING WDNR RCLS

CLIENT	WAUKESHA COUNTY 515 W. MORELAND BLVD. WAUKESHA, WI 53188	SITE	FORMER FIRESTONE PROPERTY S73 W16437 JANESVILLE ROAD MUSKEGO, WISCONSIN	ENGINEER	SCS ENGINEERS 2830 DAIRY DRIVE MADISON, WI 53718-6751 PHONE: (608) 224-2830	SOIL ANALYTICAL RESULTS
	PROJECT NO. 25212113.00		DRAWN BY: KP			FIGURE 3
	DRAWN: 06/19/13		CHECKED BY: REL			
	REVISED: 11/13/13		APPROVED BY: REL 11/14/13

Soil contamination remains in two locations as indicated on the attached map Soil Analytical results, Figure 3, Revised 11/13/13. If soil in the specific locations described above is excavated in the future, the property owner or right-of-way

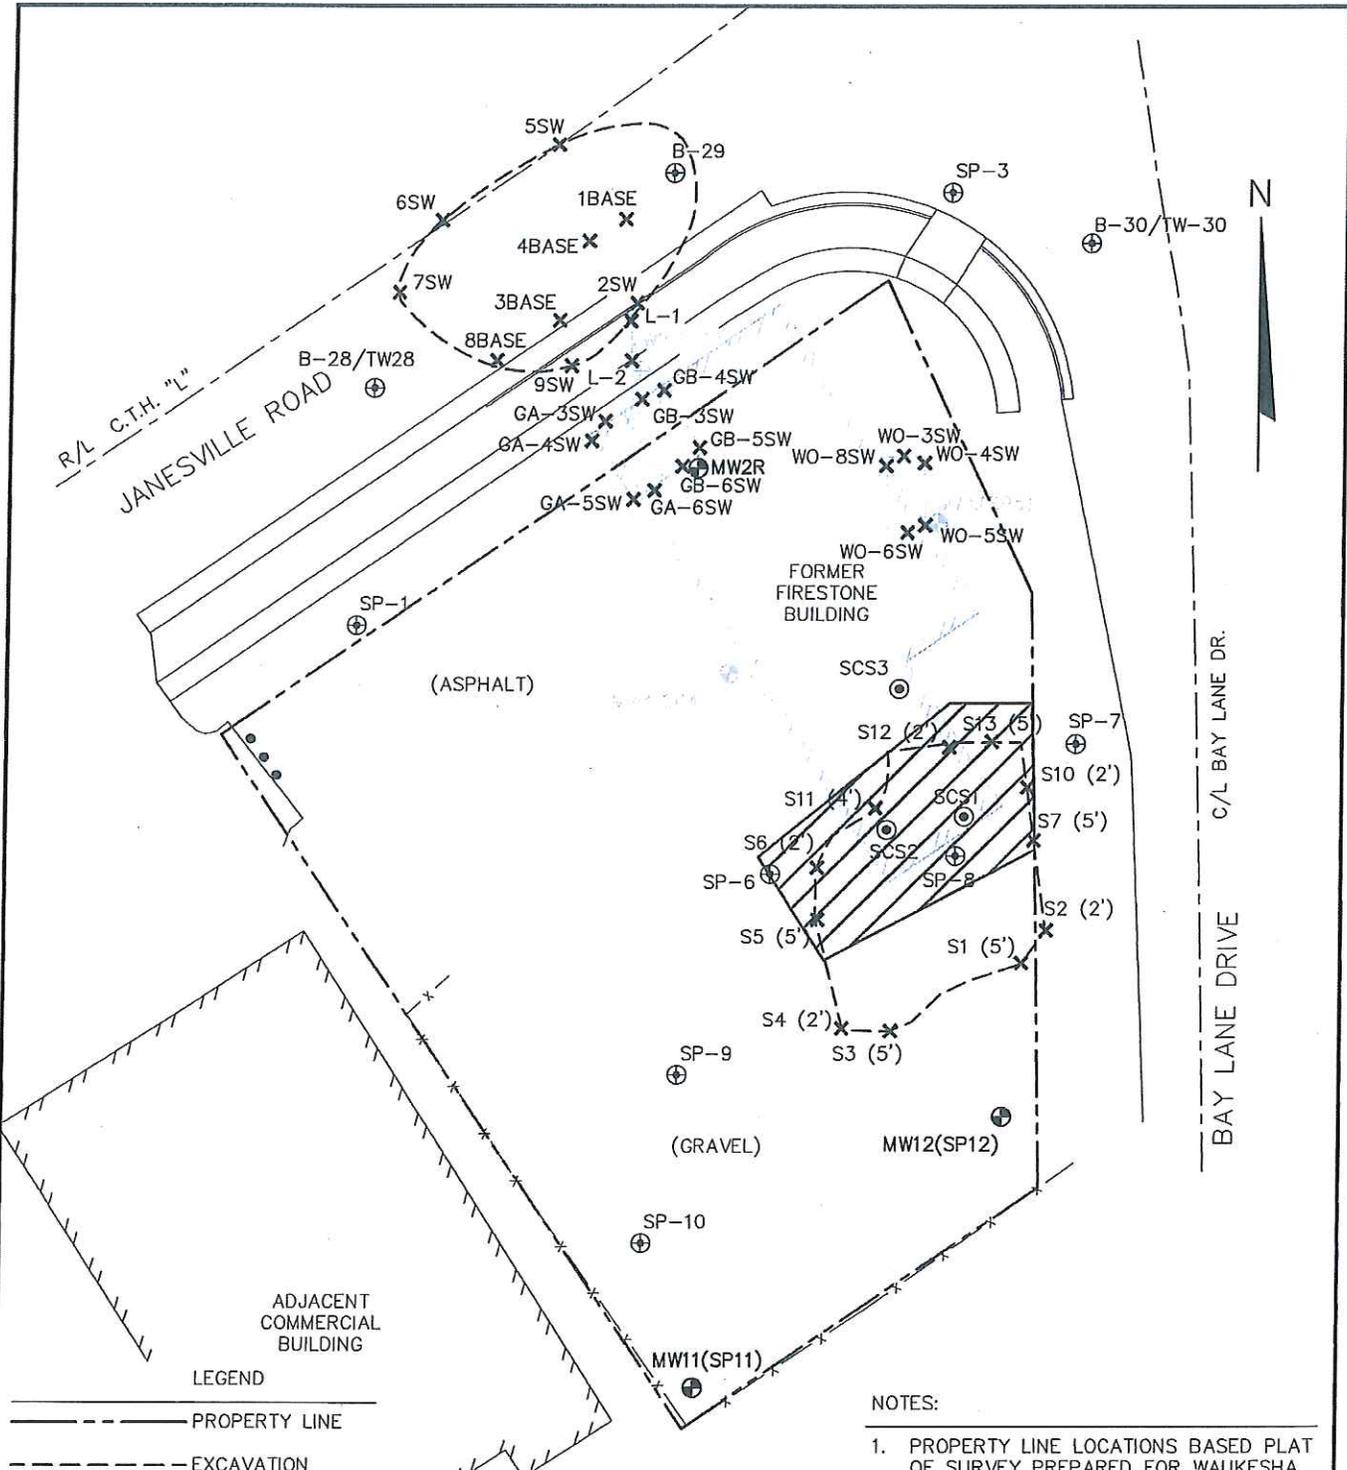
- LEGEND**
- PROPERTY LINE
 - - - EXCAVATION
 - ⊕ MONITORING WELL
 - ⊙ SOIL BORING
 - × EXCAVATION SAMPLE
 - ▨ SOIL CAP

CLIENT	WAUKESHA COUNTY 515 W. MORELAND BLVD. WAUKESHA, WI 53188		SITE	FORMER FIRESTONE PROPERTY S73 W16437 JANESVILLE ROAD MUSKEGO, WISCONSIN		CAP MAINTENANCE AREA	
	PROJECT NO.	25212113.00		DRAWN BY:	KP	SCS ENGINEERS 2830 DAIRY DRIVE MADISON, WI 53718-6751 PHONE: (608) 224-2830	FIGURE
DRAWN:	04/23/12	CHECKED BY:	TM	ENGINEER			
REVISED:	01/08/14	APPROVED BY:	REL 01/08/14

Certain activities are prohibited at closed sites because maintenance of a barrier is intended to prevent contact with any remaining contamination. When a barrier is required, the condition of closure requires notification of the DNR before making a change, in order to determine if further action is needed to maintain the protectiveness of the remedy employed. The following activities are prohibited on any portion of the property where a soil cover is required, as shown on the attached map Cap Maintenance Area, Figure 1 Revised 01/08/14, unless prior written approval has been obtained from the DNR:

The soil cover that exists in the locations shown on the **attached map** Cap Maintenance Area, Figure 1 Revised 01/08/14 shall be maintained in compliance with **the attached** January 2014 Cap Maintenance Plan in order to prevent direct contact with residual soil contamination that might otherwise pose a threat to human health.

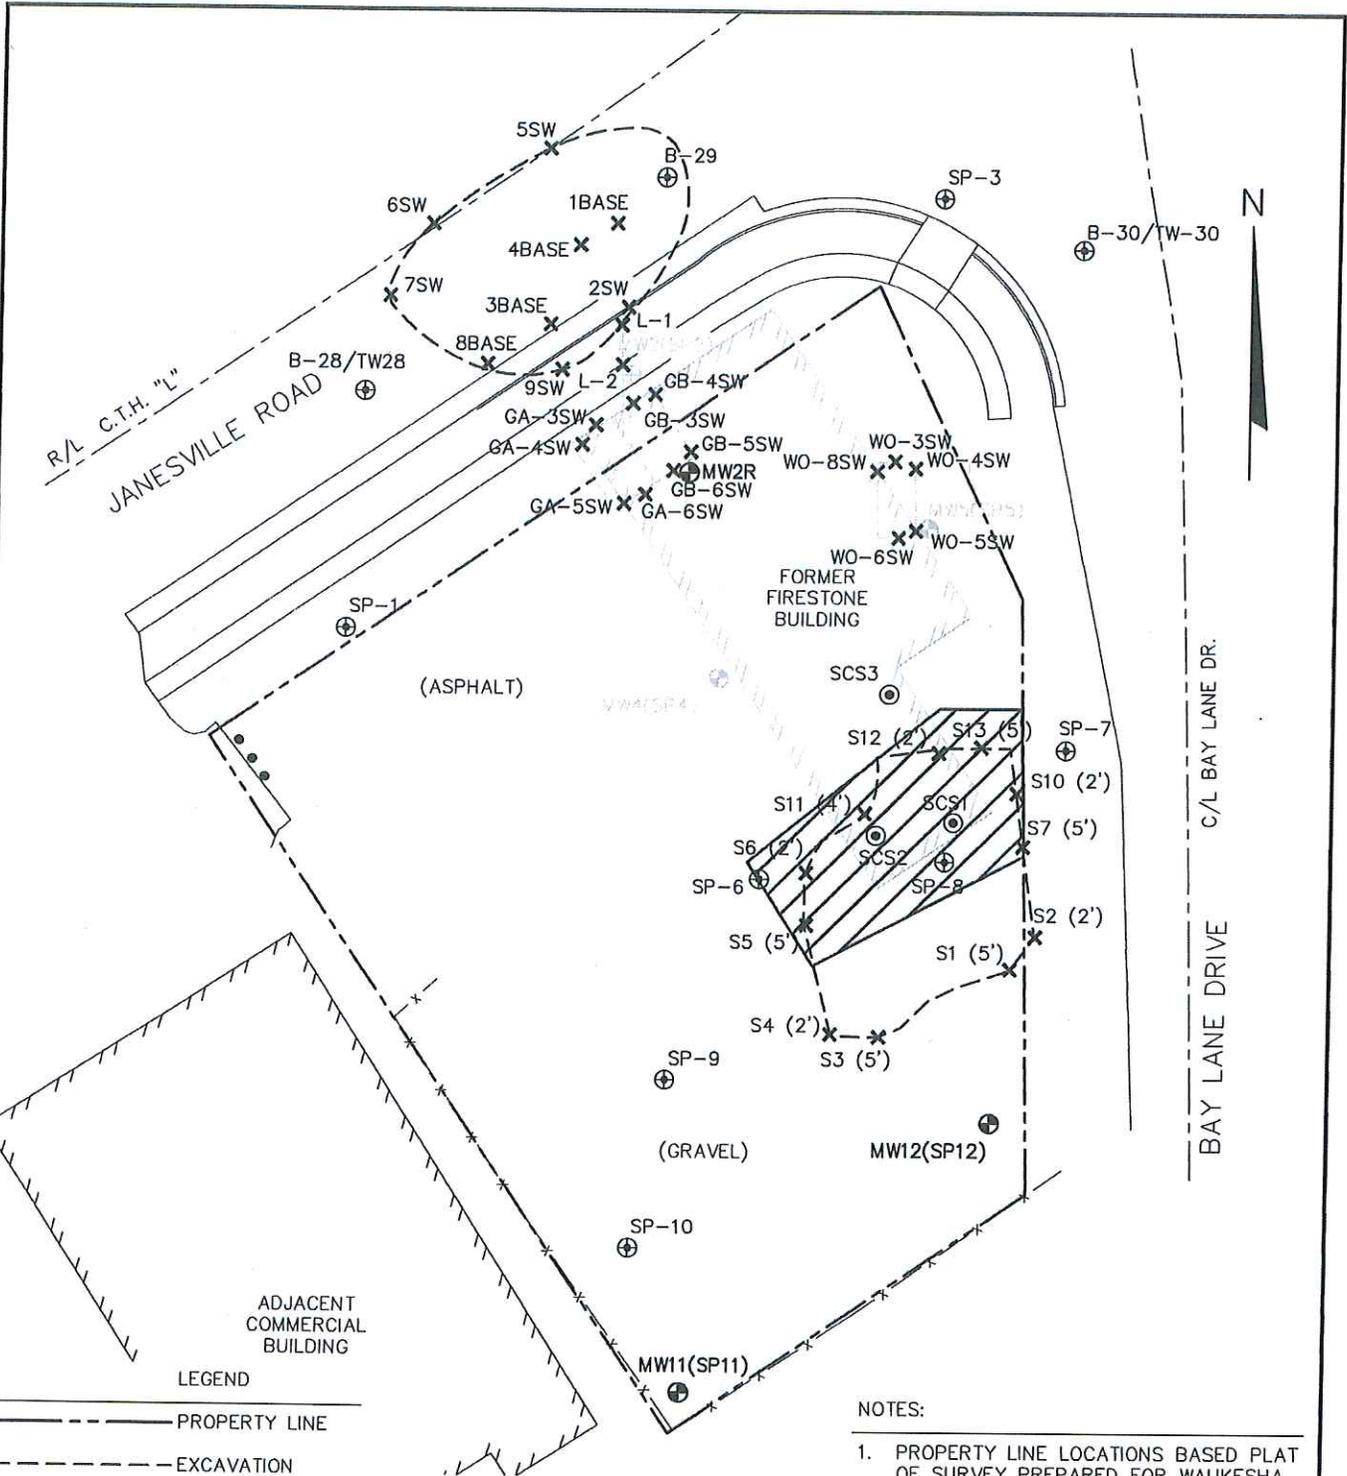
FIGURE 1

Cap Maintenance Area

- PROPERTY LINE
- EXCAVATION
- MONITORING WELL
- SOIL BORING
- EXCAVATION SAMPLE
- SOIL CAP

This document is the Maintenance Plan for a soil cap at the above-referenced property in accordance with the requirements of s. NR 724.13(2), Wisconsin Administrative Code. The maintenance activities relate to the soil cap that occupies the area over contaminated soil on site. The soil cap is two feet of clean soil. The contaminated soil is impacted by polycyclic aromatic hydrocarbons (PAHs). The location of the soil cap that is maintained in accordance with this Maintenance Plan, as well as the impacted soil, is identified on the attached map (**Figure 1**). Photos of the cap are included in **Appendix B**. The property owner, or successive owners, will maintain the cap in accordance with this plan.

The soil cap overlaying the contaminated soil, as depicted on **Figure 1**, will be inspected once a year, normally in the spring after all snow and ice are gone, for deterioration, erosion, and other potential problems that can cause additional infiltration into underlying soils. The inspections will be performed to evaluate damage due to settling, exposure to the weather, and other factors. Any areas with obvious erosion will be documented and repaired. A log of the inspections and any repairs will be maintained by the property owner and is included in **Appendix C**, Cap Inspection Log. Once repairs are completed, they will be documented in the inspection log. A copy of the inspection log will be maintained by the Waukesha County, unless otherwise directed in the case closure letter.

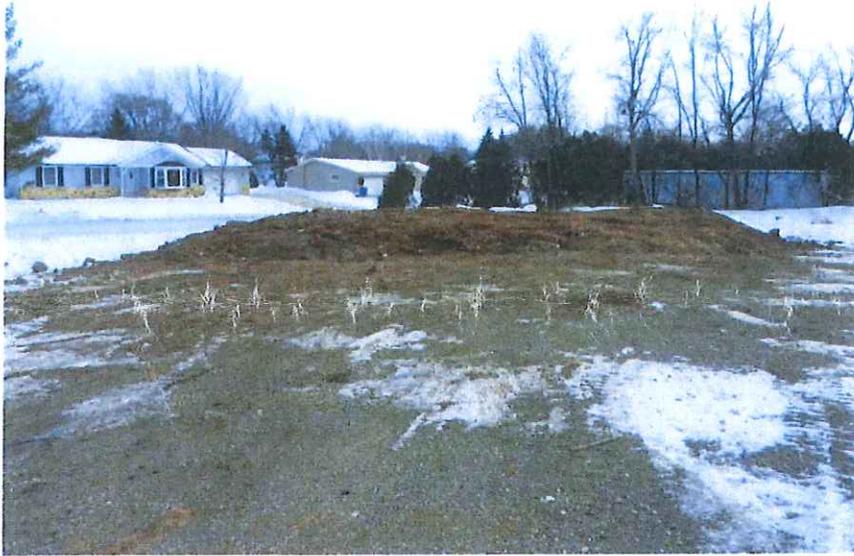
Photo 1: View of soil cap looking southeast

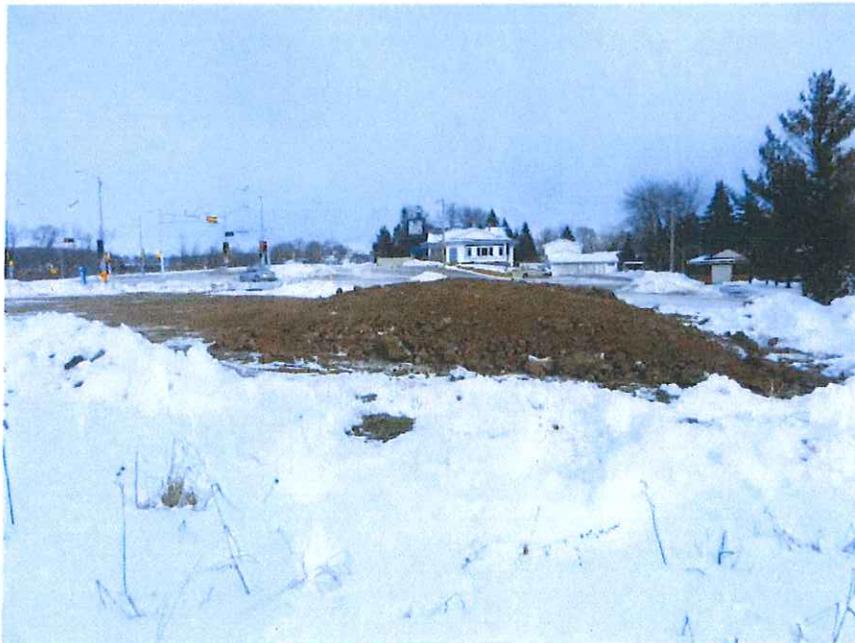
Photo 2: View of soil cap looking northeast
