# **Phase I Environmental Site Assessment**

**University of Wisconsin – Milwaukee  
Waukesha Campus  
1500 N. University Drive  
Waukesha, Wisconsin**

**February 4, 2025  
Project No. 1E-2501002**

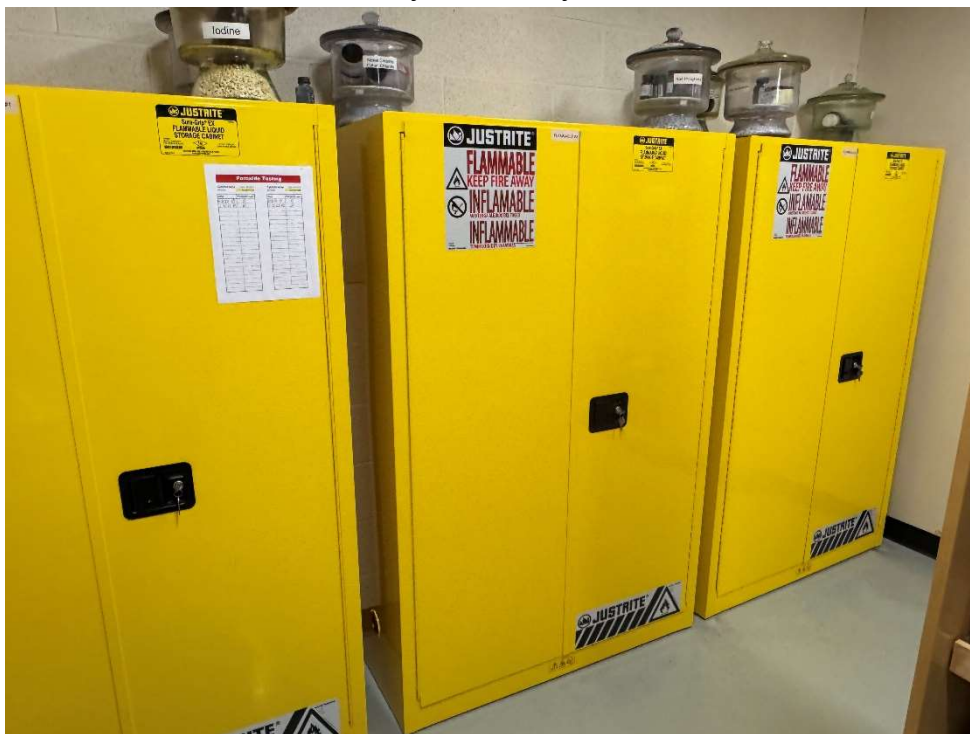
View of the Chemistry Department's hazardous materials store room in Northview Hall.

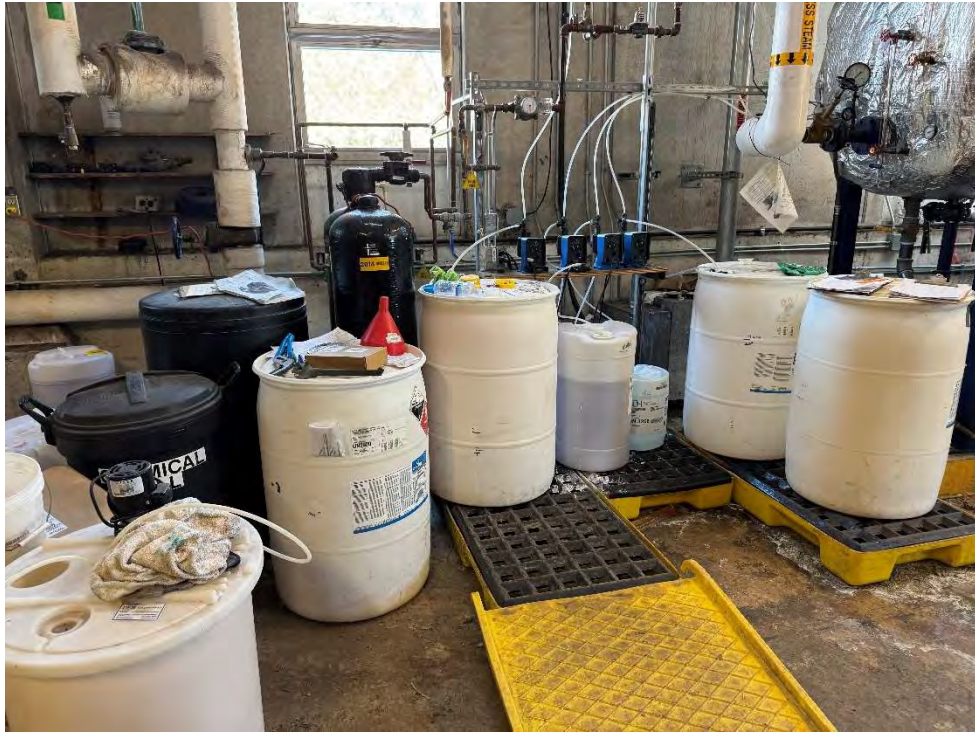
View of boiler chemicals stored in the boiler room.
